Trail Creek Watershed Analysis

Bureau of Land Management
Medford District, Oregon
June 1999

TRAIL CREEK WATERSHED ANALYSIS

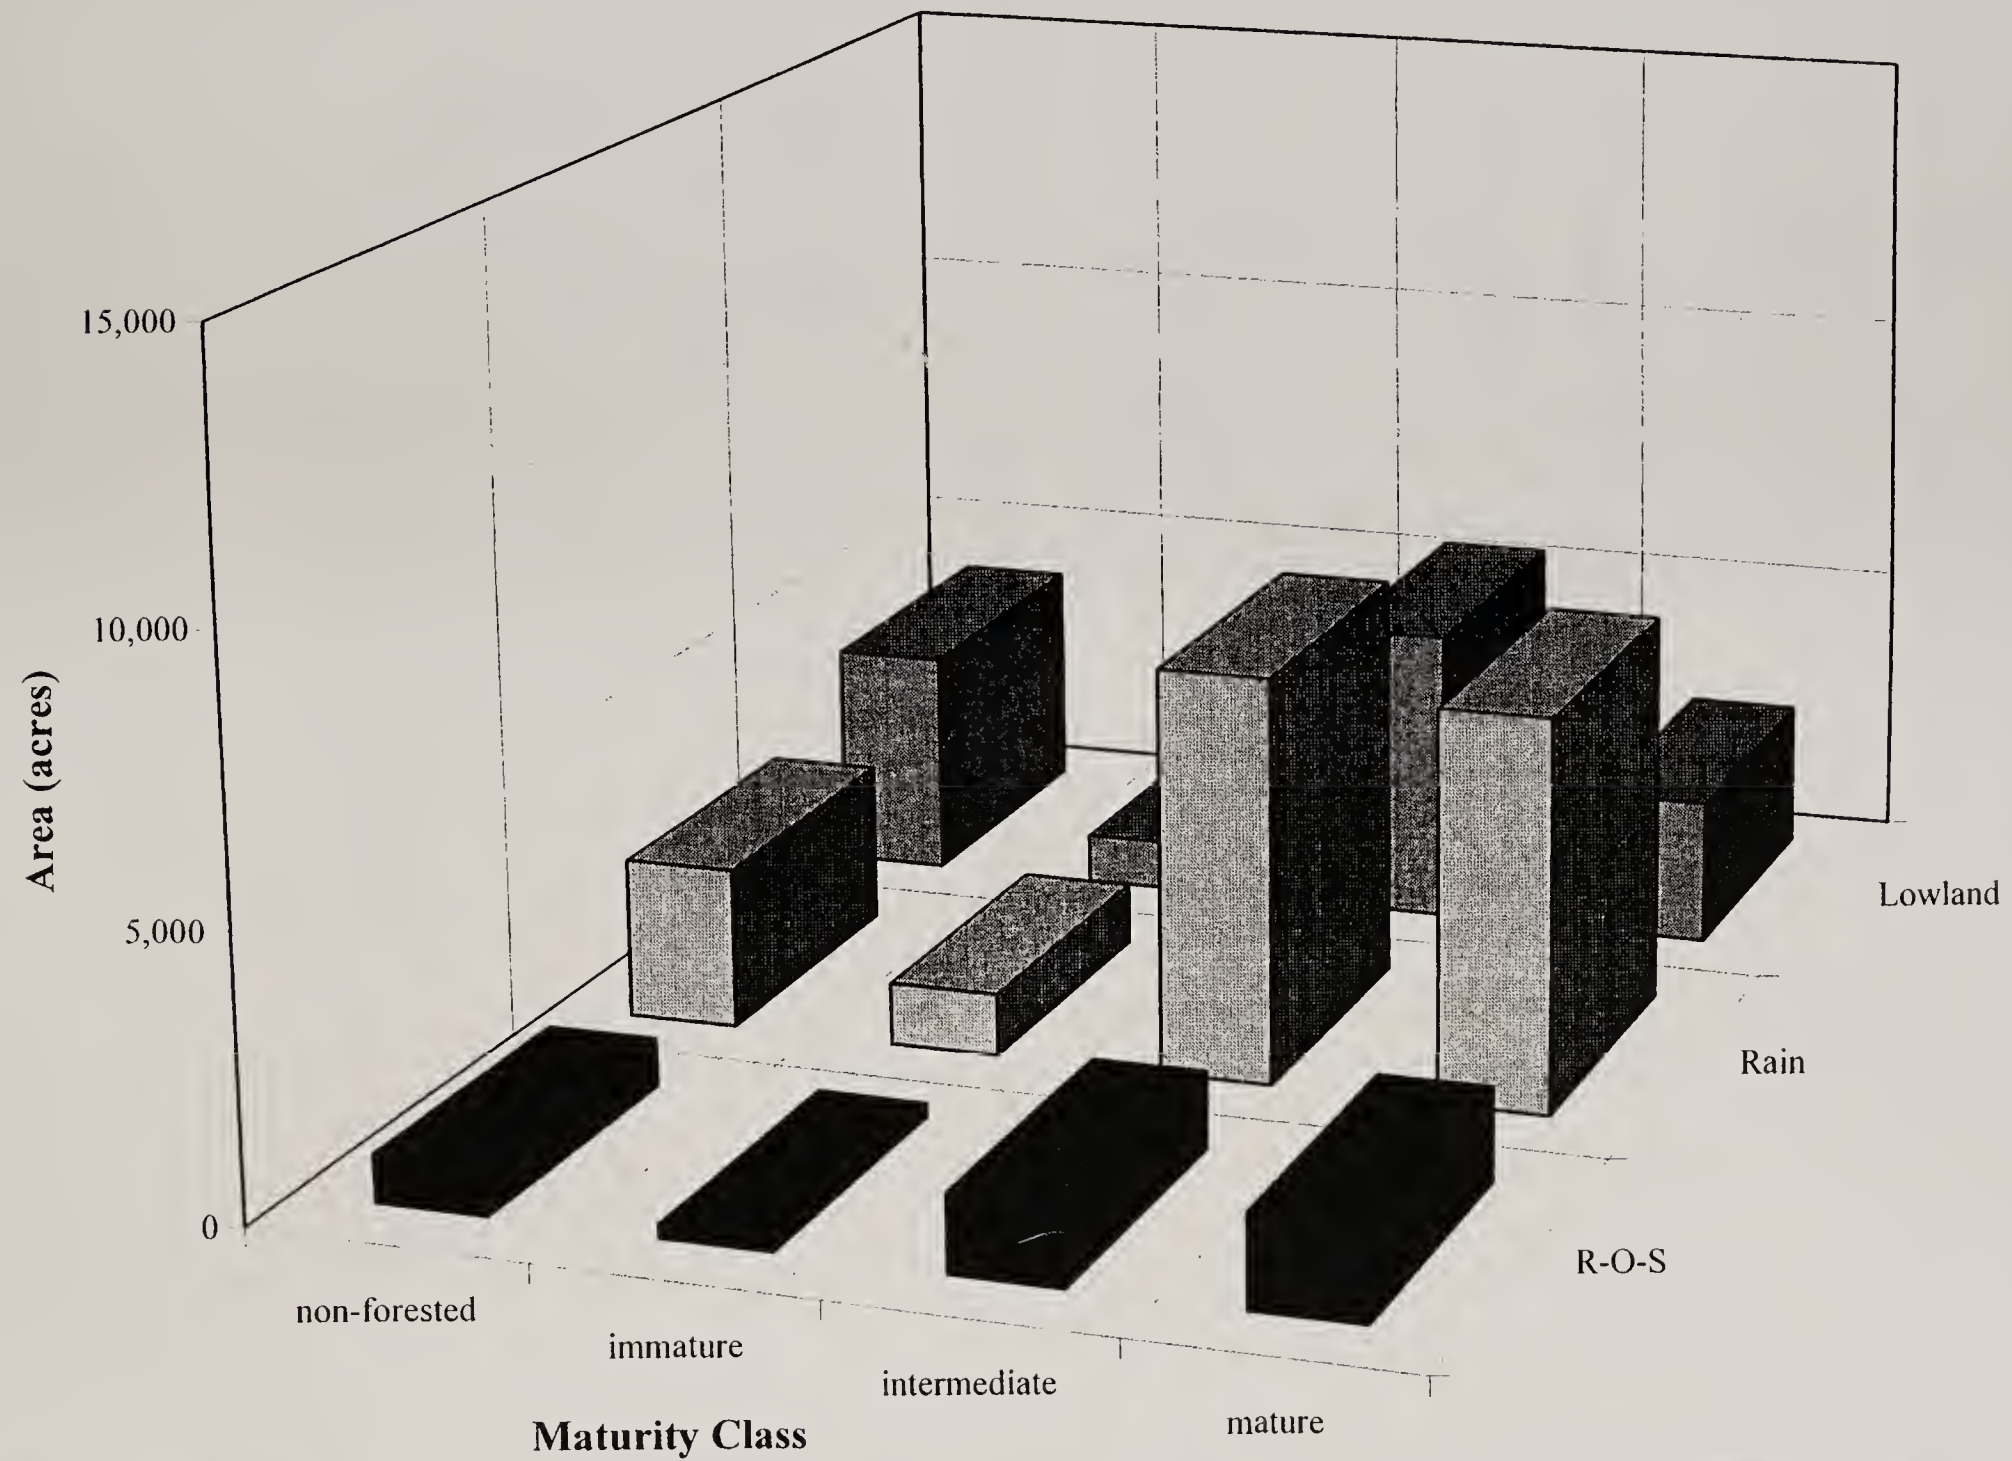
Figure C-1. Acreage by Precipitation Zone and Cover Type, Current Conditions - Trail Creek Watershed

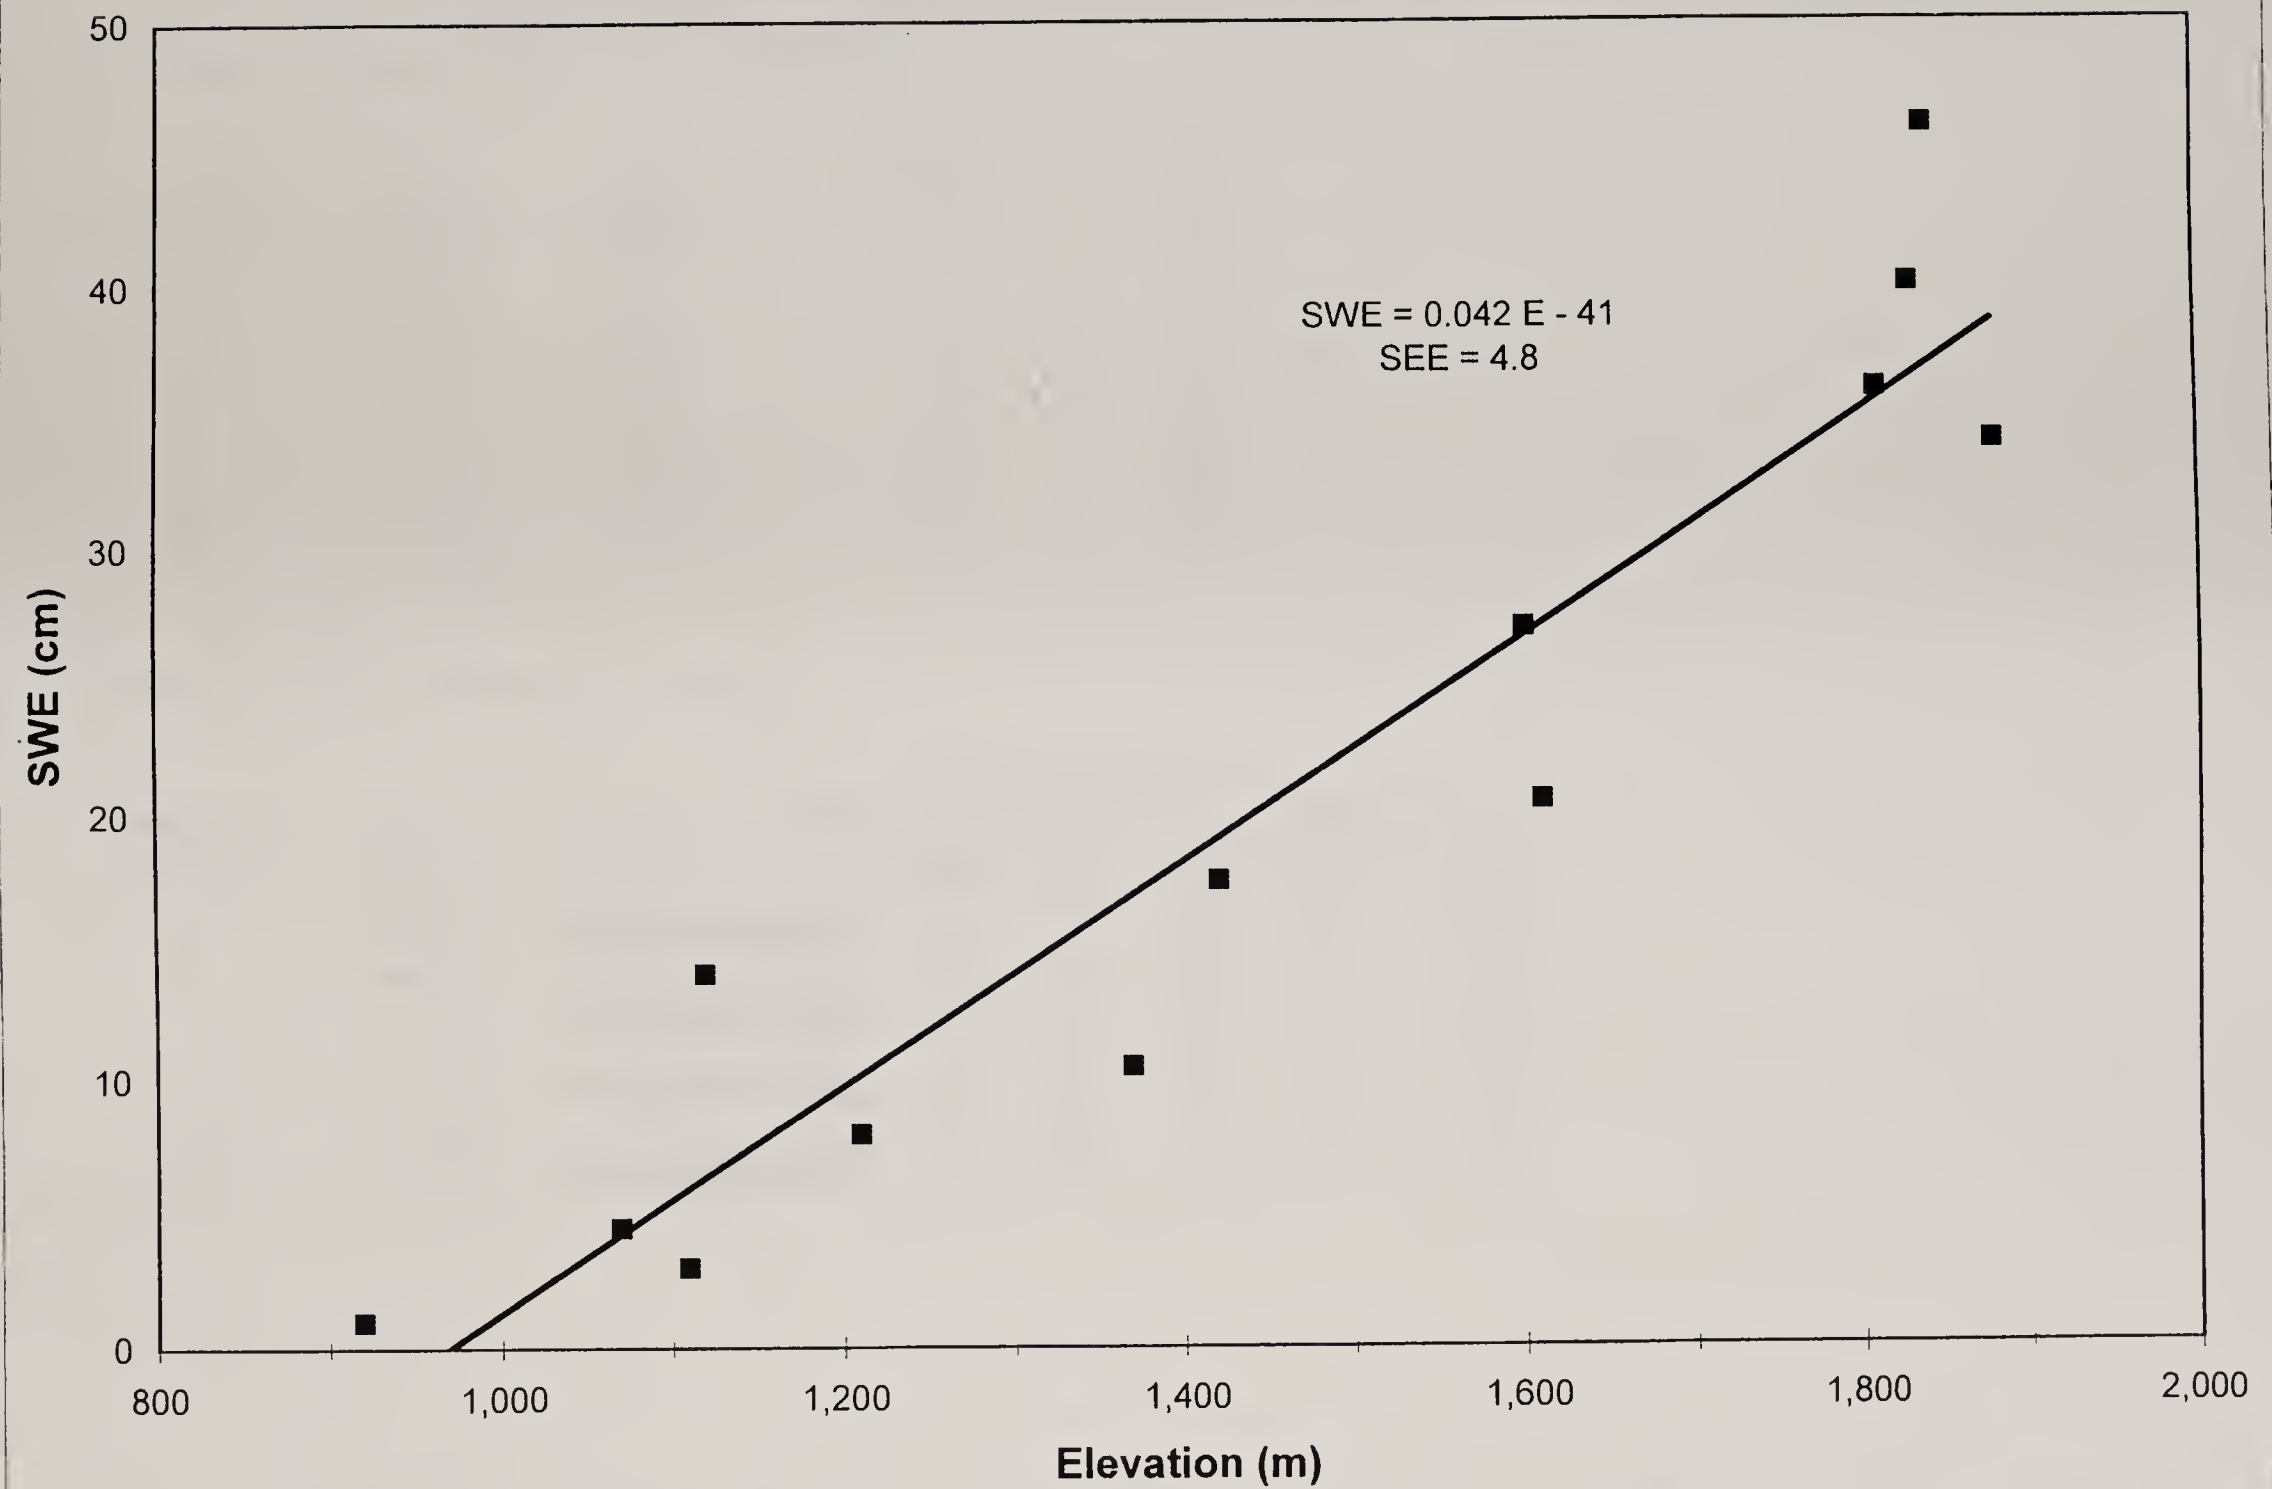
Figure C-2. January 1 Snow-Water Equivalent

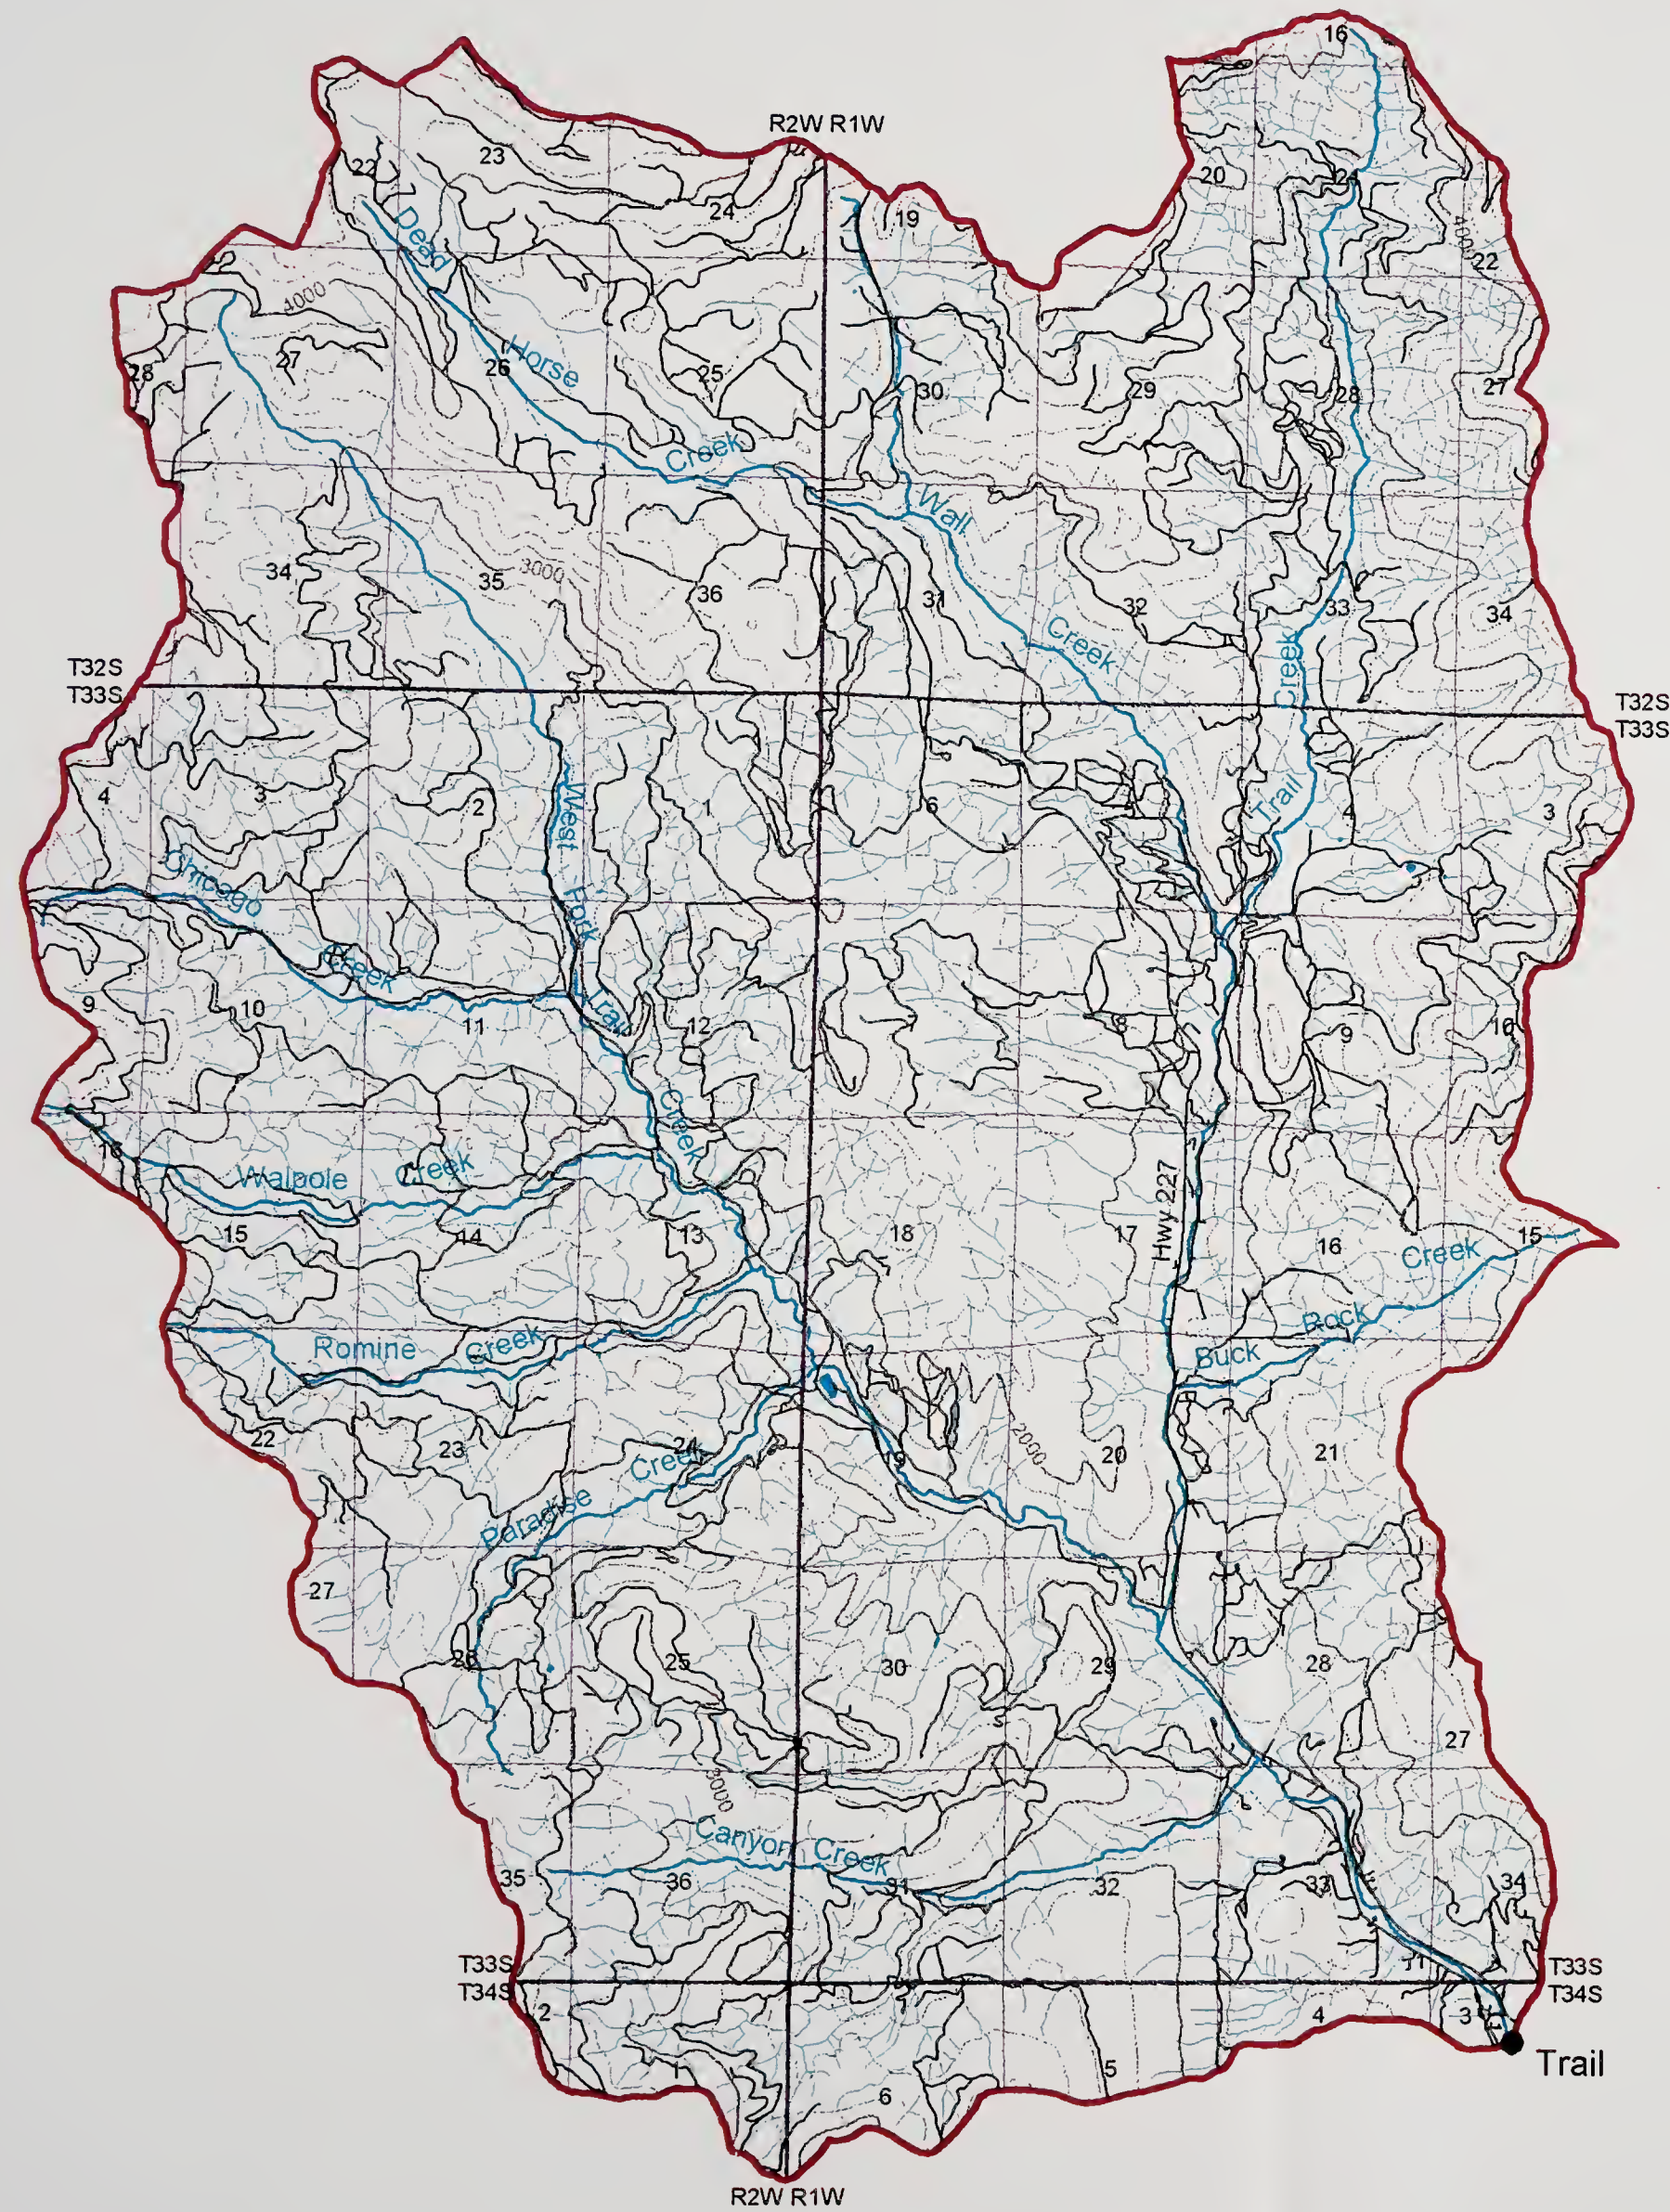
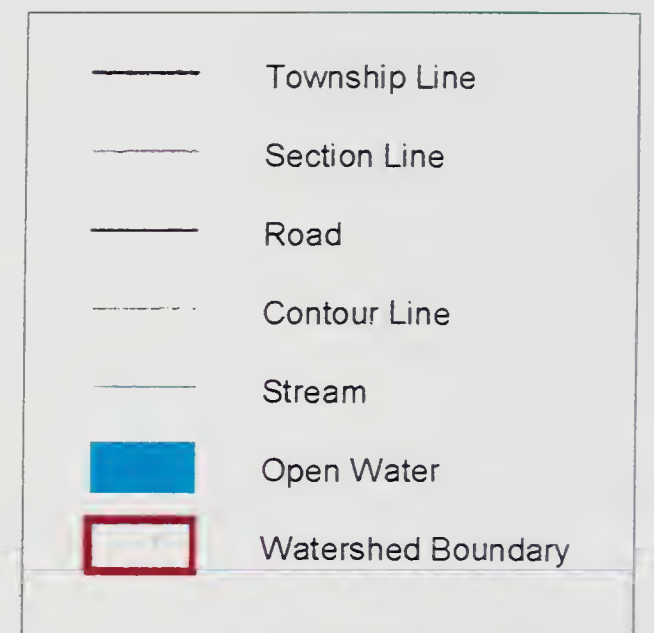
Trail Creek Watershed
Trail Creek Watershed Analysis
Medford District BLM
FIGURE 1-2

Note: Contours equal 200 foot intervals and are labeled at 1000 foot intervals

The Trail Creek fifth-field watershed is located in southwestern Oregon between Medford and Crater Lake National Park along the Rogue River within the Upper Rogue River Sub-basin (Figure 1-1). The watershed covers approximately 55 square miles within the sub-basin which covers about 1,618 square miles. The Trail Creek watershed is accessed by State Highway 227 from the Canyonville I-5 interchange to the northwest, by State Highway 62 from Medford to the southwest, or by the same route from Crater Lake to the northeast. The towns of Trail and Shady Cove (population approximately 2,379) are within or adjacent to the watershed. Most of the watershed is within Jackson County (population approximately 146,389), though the northern portion lies within Douglas County (population 94,649). The Trail Creek itself is situated north and west of the Rogue River and extends upslope to the divide with the South Umpqua River to the north (see Figure 1-2).

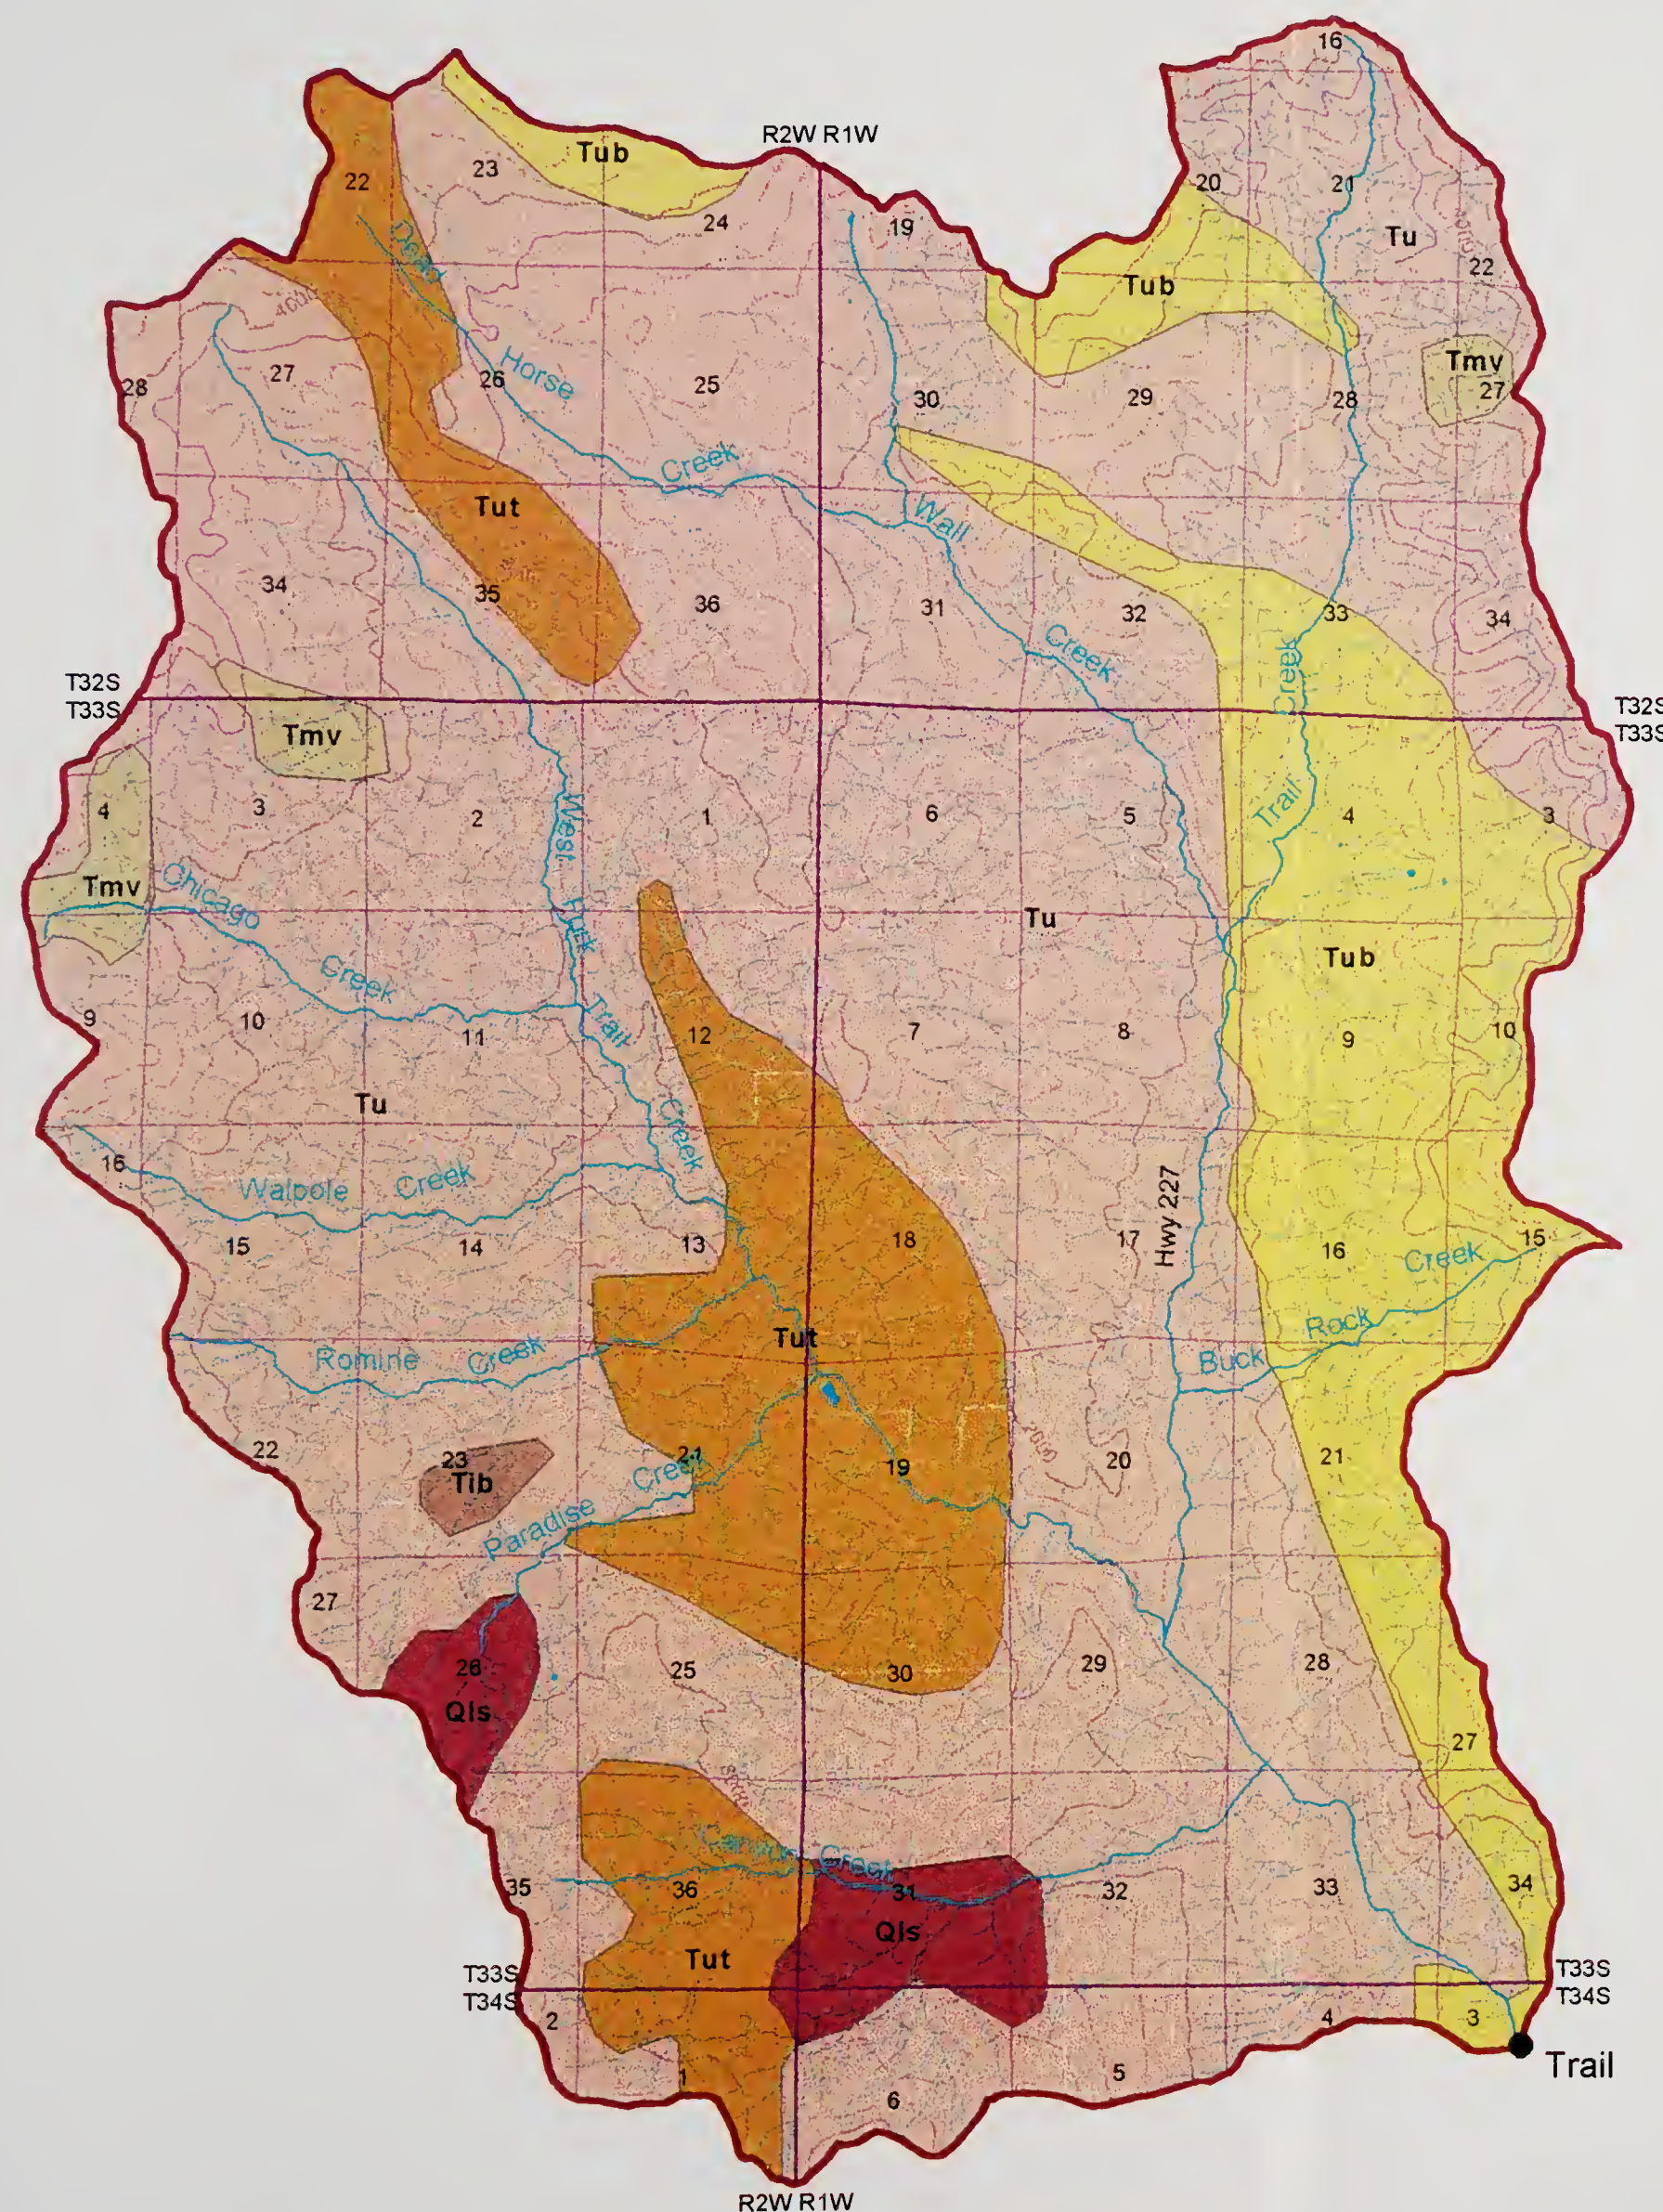
- Qls Ancient Landslide Deposits (Quaternary)
- Tib Basaltic and Andesitic Sills, Dikes, and Plugs (Pliocene, Miocene, and Oligocene)
- Tmv Mafic Intrusive Dikes, Plugs, Thin Flows and Cinders (Miocene)
- Tu Heterogeneous Stratified Volcanic Flows and Tuffaceous Sediment Interbeds (Miocene and Oligocene)
- Tub Basalt, Andesite, and Breccia Flows (Miocene and Oligocene)
- Tut Ash-Flow Tuff (Tertiary)

Geology Map Units
Trail Creek Watershed Analysis
Medford District BLM
FIGURE 1-4

The entire Trail Creek basin is formed from Tertiary (1.6 to 66 million years before present) Western Cascade volcanoclastic rocks originally deposited predominantly as flows and ash deposits on a nearly flat to gently sloping landscape. Formations found in the watershed include basaltic and andesitic lava flows and flow breccias, including stratified and interbedded tuffaceous (ash) sediments and volcanic conglomerates, and ash-flow tuff, the latter found within the central portion of the West Fork basin (see Figure 1-4). The watershed has not been glaciated, and little structural deformation has occurred since deposition of the volcanoclastic flows. Although some minor faulting is evident in the watershed, the stream system has generally been free to downcut into and through the volcanic layers unhindered by structural controls, thus developing in a classic dendritic form, and with very few exceptions, developing a normal sequence of high gradient tributaries leading to progressively lower gradient and larger channels.

rugged topography with irregular ridges and deep narrow valleys. Quaternary (1.6 million years ago to present) alluvial floodplain deposits occur along the lower reaches of the West Fork and Trail Creek. Gentle to moderate slopes predominate in the southern and lower elevations of the watershed, with slope steepness generally increasing with increasing elevation to the north, towards the watershed's margins. Internally within the watershed these conditions exist where sharp ridges occur between major tributaries where in some cases substantial flow-edge rock escarpments (cliffs) have formed. Steep slopes are also found where tributaries are deeply incised, forming inner gorges, although inner gorges are not a dominant feature.

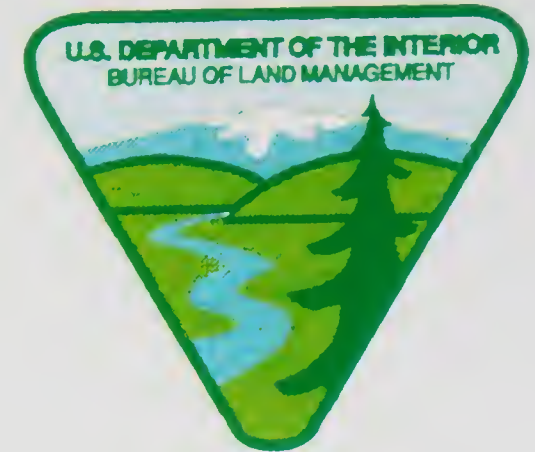
Hydrologic Features
Trail Creek Watershed Analysis
Medford District BLM
FIGURE 1-5

Sub-Watershed Boundary

¹ Seven logical divisions of the watershed were delineated and are referred to as sub-watersheds (Figure 1-5) for the hydrologic analysis. These same sub-watersheds were used to facilitate the mass wasting, surface erosion, and sediment budget analyses.

The Trail Creek watershed was divided into 7 sub-watersheds⁹ (Figure 1-5) for the purposes of this hydrologic assessment. These sub-watersheds allow examination of the potential effects of vegetative manipulation in different areas of the watershed which vary in precipitation and temperature characteristics, and also allow examination of effects as they accumulate in a downstream direction. Current vegetation conditions in the watershed are shown in Figure 1-6. Descriptions of each map unit can be found in Section 1.4. Table C-1 (Appendix C) summarizes vegetation condition by rain-on-snow potential zone by sub-watershed, and a summary of this information for the entire watershed is presented in Figure C-1 (Appendix C).

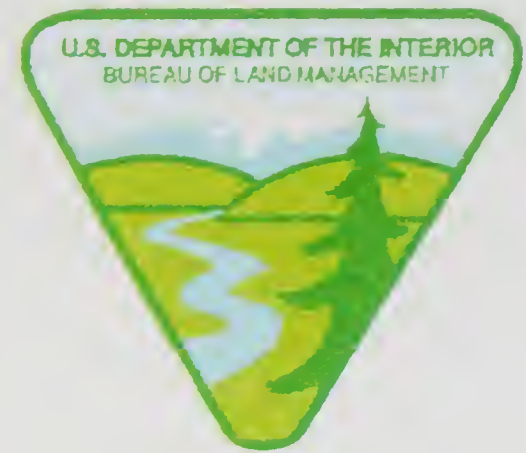
Landslide Inventory
Trail Creek Watershed Analysis
Medford District BLM
FIGURE 3-2

- Road Related / Shallow Rapid Failure
- Road Related / Small Sporadic Deep-Seated
- ▲ Harvest Related / Shallow Rapid Failure
- ▲ Harvest Related / Small Sporadic Deep-Seated
- Natural Related / Shallow Rapid Failure
- Sub-Watershed Boundary

Aerial photo analysis and field investigations were used to analyze the hazard for mass wasting for the Trail Creek watershed. Four sets of aerial photographs were examined to identify landslide locations and the history of mass wasting in the watershed (1966/69, 1975, 1985, and 1996). Locations of landslides observed on the aerial photos were plotted on a watershed base map (Figure 3-2), and landslide features were recorded in a database (Appendix A, Table A-1).

- Prioritize watershed restoration projects in areas where roads accelerate landslide and erosion that deliver sediment to streams.
- Use the BLM Trail Creek road inventory Table B-6, Mass Wasting Appendix Table A-1, Figures 3-2 (Landslide Inventory Map) and 3-3 (Mass Wasting Management Unit Map) to identify road segments with existing and potential landslides that have or may in the future deliver sediment to streams.
- Designate Riparian Reserves to include active and potentially active landslides.
- Adopt mass wasting management recommendations for harvest units within each of the four mass wasting management units mapped within the watershed.

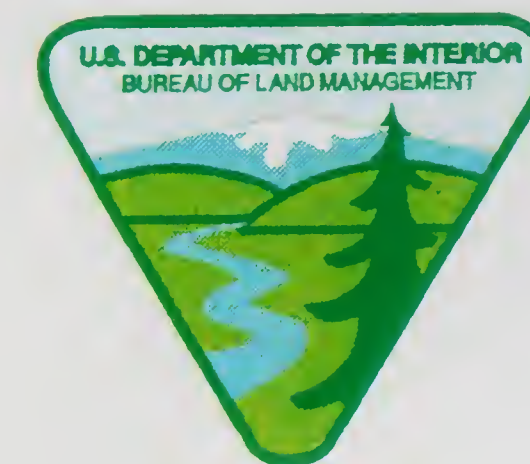
Mass Wasting Management Units
Trail Creek Watershed Analysis
Medford District BLM
FIGURE 3-3

- Mass Wasting Management Units
- MWMU No. 1
 - MWMU No. 2
 - MWMU No. 3
 - MWMU No. 4
 - Sub-Watershed Boundary

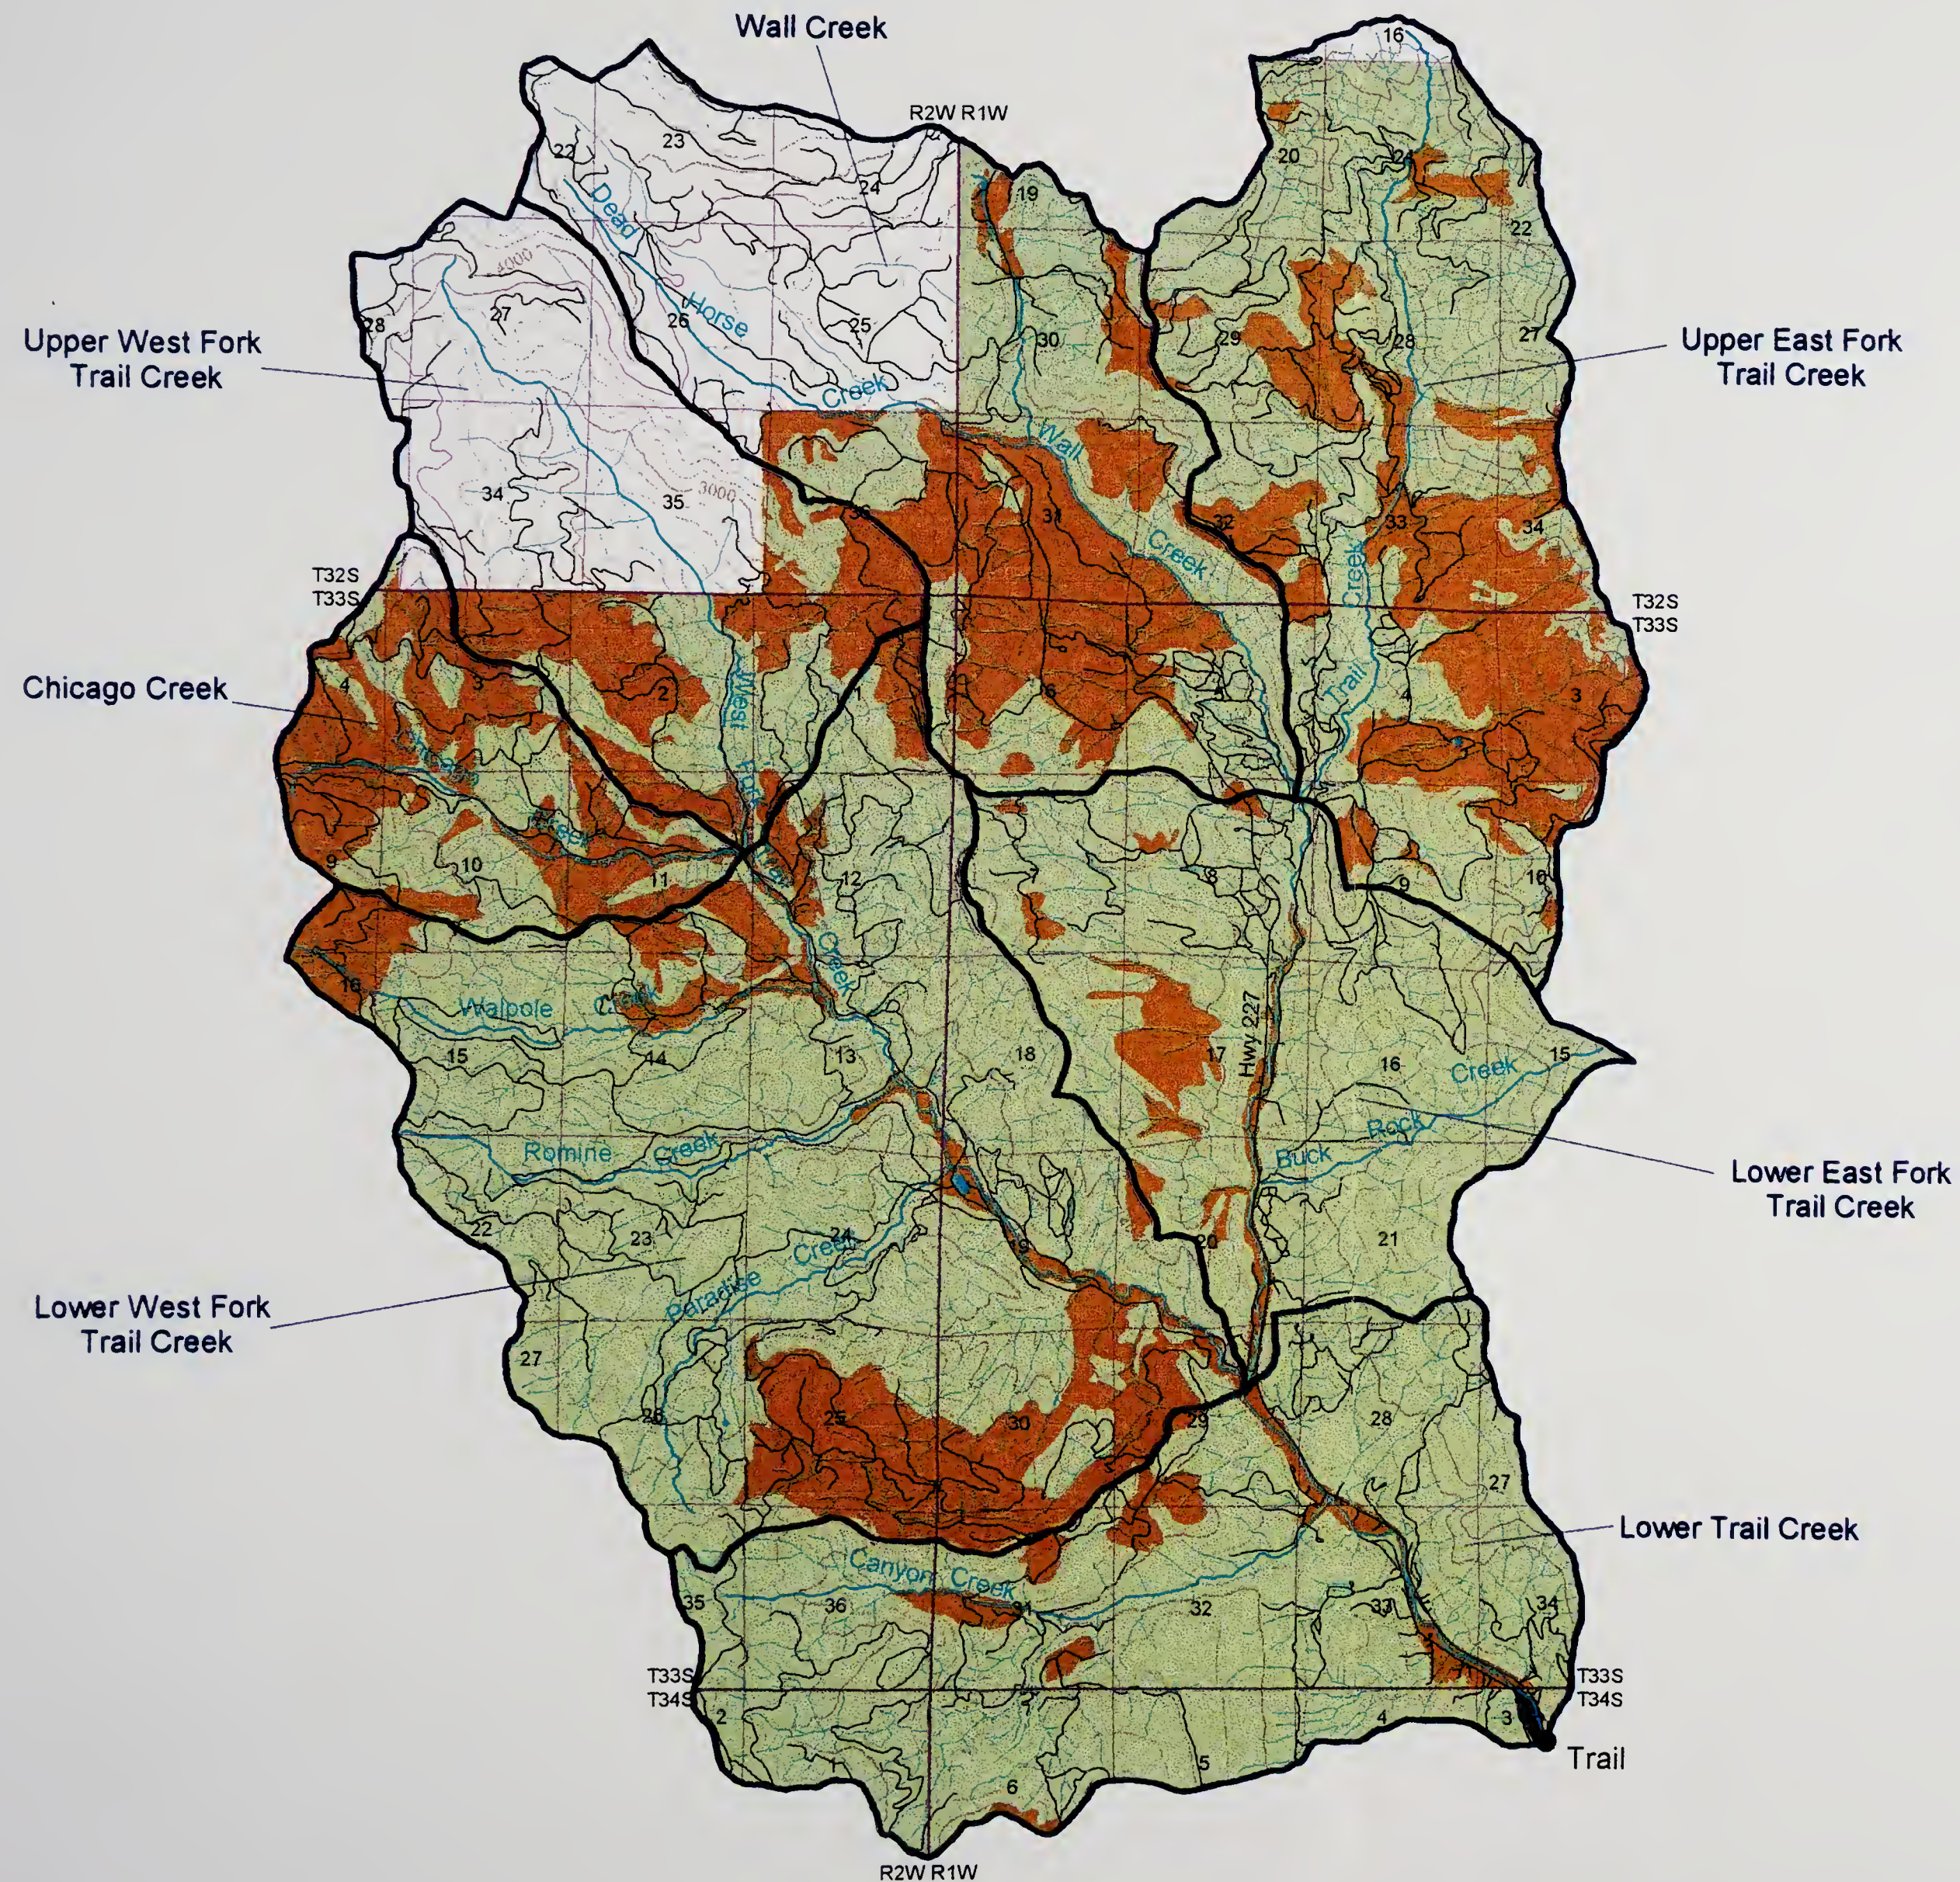
Soil K Factors
Trail Creek Watershed Analysis
Medford District BLM
FIGURE 3-4

The soil erodibility "K" factor for soil found in the watershed in few cases reaches the criteria for moderate erodibility ($K = 0.25$ to 0.40), and then only for subsoil horizons. The Soil Survey of Jackson County (USDA SCS, 1993) describes this soil as having moderate to high erodibility. This soil is subject to erosion where exposed and compacted or puddled with associated destruction of internal macroporosity leading to surface runoff, and that delivery of sediment to streams is a concern, particularly on steep slopes. Again due to their high clay content, road surfaces have poor bearing strength when wet, and unsurfaced roads are subject to rutting, concentration of surface flows, and delivery of sediment to streams. Heavily used ground-based skid trails are subject to severe compaction, generation of surface flows, erosion, and attendant sediment delivery potential if poorly drained and located. Since few areas within the watershed have been harvested within the past five years, with no areas harvested in this period on BLM and Forest Service ownership, it is unlikely that sediment delivery associated with harvesting currently adds significant volumes of sediment to Trail Creek streams.
